COLLEGE PARK DESIGN GUIDELINES

COMMUNITY MASTER PLAN

City of Lake Worth
Florida

Jan
Abell Garcia Architects
December, 1999

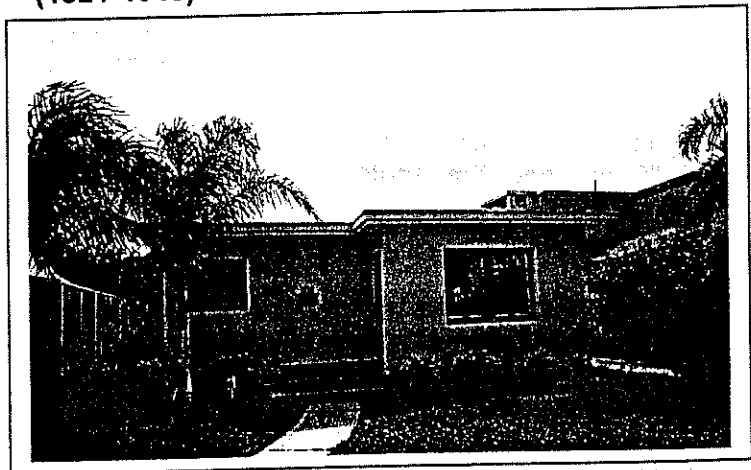
311 Columbia

Brick, the most common masonry material in the United States, was not readily available until the turn of the century in Florida, because of poor transportation facilities and the indigenous soil content. Contractors for early brick structures in Florida, including fortifications, lighthouses, and arsenals, imported brick from other states for their works. As rail networks began to penetrate the Florida peninsula, brick became more readily available.

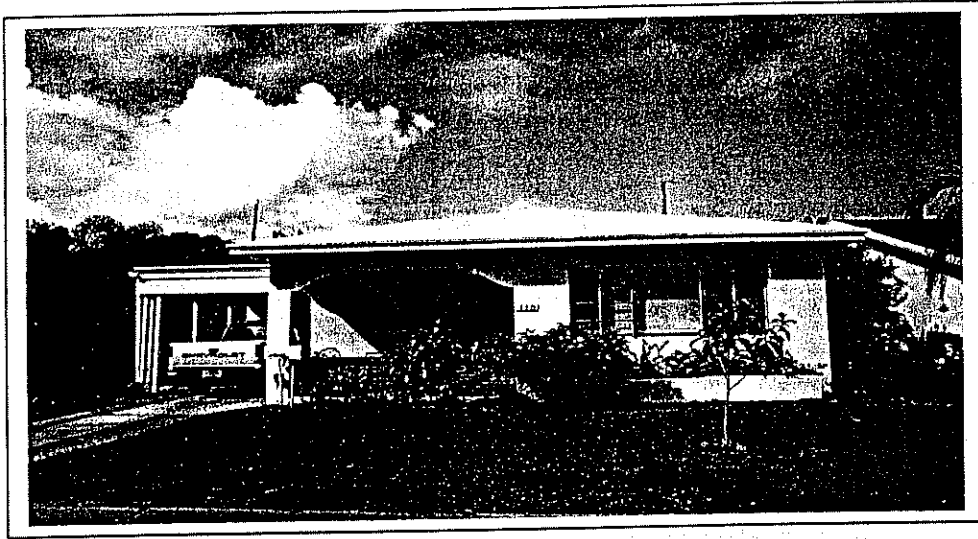
330 Cornell

- Plan: regular, rectangular.
- Foundation: continuous or slab (commercial), brick or concrete.
- Height: one-two stories (apartments); one-two stories (commercial).
- Primary exterior material: brick, common or running bond; stucco, rough texture; concrete block, rusticated rock-faced.
- Roof type: hip; flat with parapet (commercial).
- Roof surfacing: composition shingles; built-up, commercial.
- Ornamentation: simple; usually cast-concrete or ornamental brick such as corbeling.

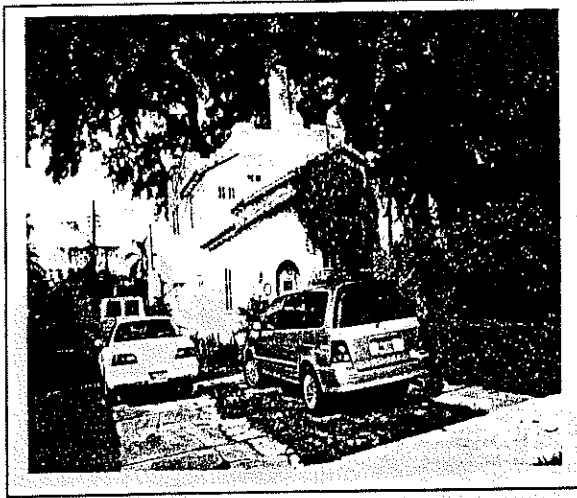
326 Fordham

Mediterranean architecture, many, particularly those designed by architects, were consciously modeled on formal styles.

- Plan: irregular.
- Foundation: continuous.
- Height: two stories.
- Primary exterior material: textured stucco.
- Roof type: combinations of hip and flat, Mission: flat with parapet curvilinear, square, crenellated.
- Roof surfacing: barrel, French interlocking tile, built up on flat roofs.
- Detailing: plaster and terra cotta detailing highlighting arches, columns, window surrounds, niches, cornices, and parapets; wrought iron grilles, balconies, and balconets.

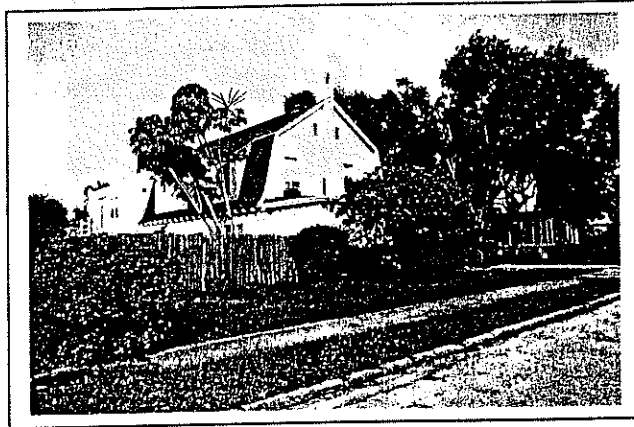
226 Princeton

The Colonial Revival style became popular at the turn of the century. In Florida it exerted a strong influence on vernacular architecture. Colonial Revival style buildings, generally residences, rose two to two-and-one-half stories in height. They displayed symmetrical massing, exhibited a tall hip roof and hip dormers, and usually maintained a one-story full facade entrance porch or veranda. One variant, the Dutch Colonial Revival, featured a gambrel roof as can be seen at 226 and 230 Princeton Drive.

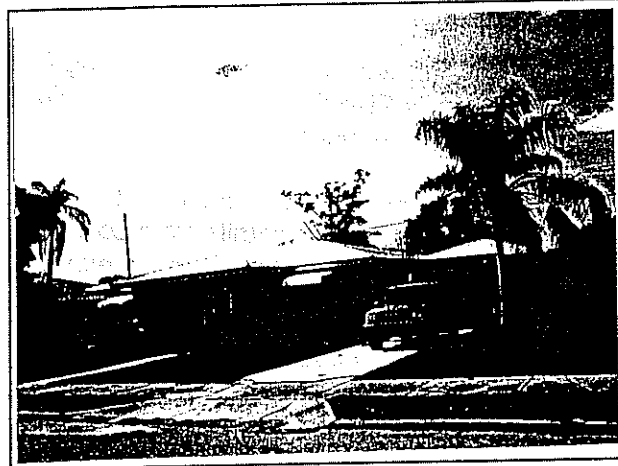
333 Vanderbilt

The Ranch style house originated in the mid 1930's in California. After World War II, the one-level Ranch Style house appeared. Ranch Style architecture is loosely based on Spanish Colonial precedents. It was a favored choice for returning veterans, and could be purchased under the G I. Bill of Rights in a minimum two bedroom version. Characteristic of the houses are small one story plans, usually slab on grade with low to medium pitch gable roofs and a low horizontal façade in general. The use of different materials bearing no discernible relationship to one another was characteristic of these "builders specials", along with the attached garage. The garage becomes a dominant feature of the house, just as the automobile provides the means by which people can move "out" of the city.

In addition to the style "ranch", the houses of this time period represent another change. The postwar house could be purchased with a "packaged mortgage," allowing the inclusion of stove, refrigerator, washing machine and dryer, and carpeting in the original financing of the house. The consumer society had arrived and Americans were happily buying a collection of expensive machines surround by the smallest possible amount of living space. The houses are further apart with yards that have side yards as well as the typical front and rear yard. The porch has moved to the rear, and in Florida the house is likely to have a patio or lanai for private living.

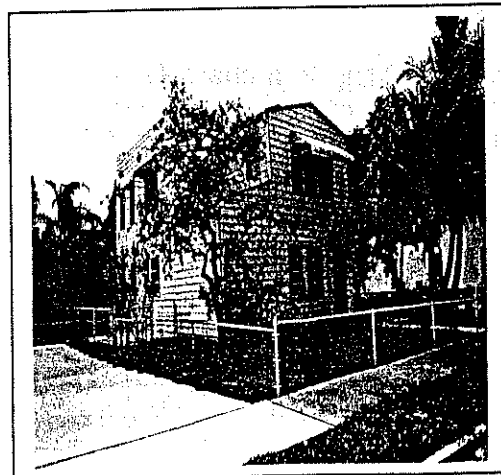
Inappropriate Siding

Aluminum and vinyl are non-historic materials. Artificial siding also frequently damages the fabric underneath. It can trap moisture and encourage decay and insect infestation.

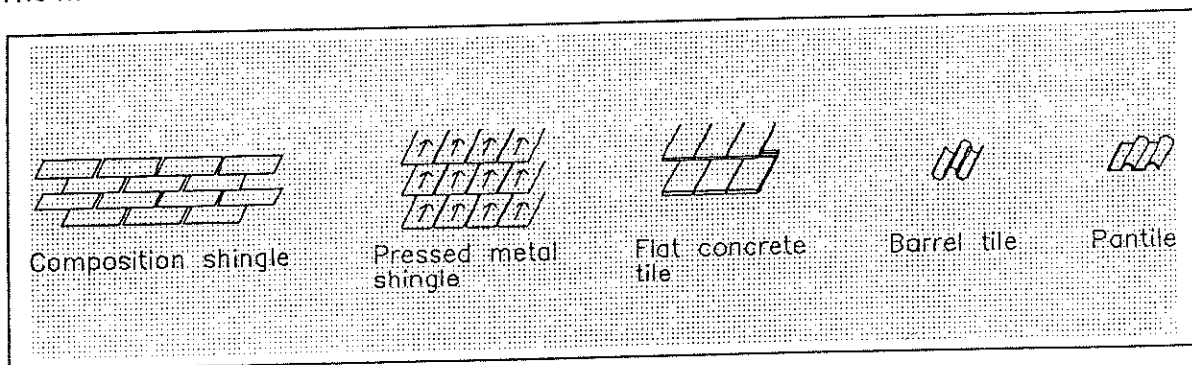
Common Roofing Materials in District

The materials used for the roofs of buildings throughout the district vary. Clay tile was often

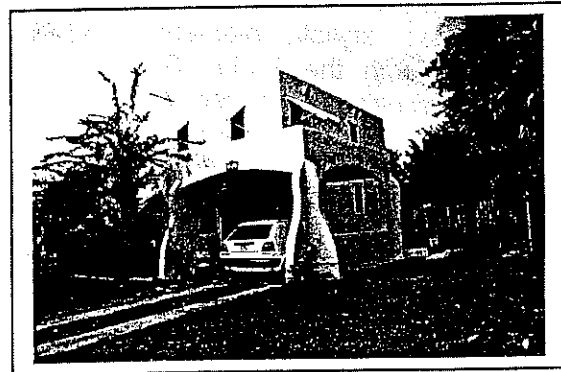
315 Columbia

Extant porches which have previously been enclosed or otherwise altered are permitted to remain under the guidelines. There is no requirement to restore an altered or missing feature. However, if enclosures or other inappropriate alterations are removed during the course of rehabilitation, they cannot be replaced.

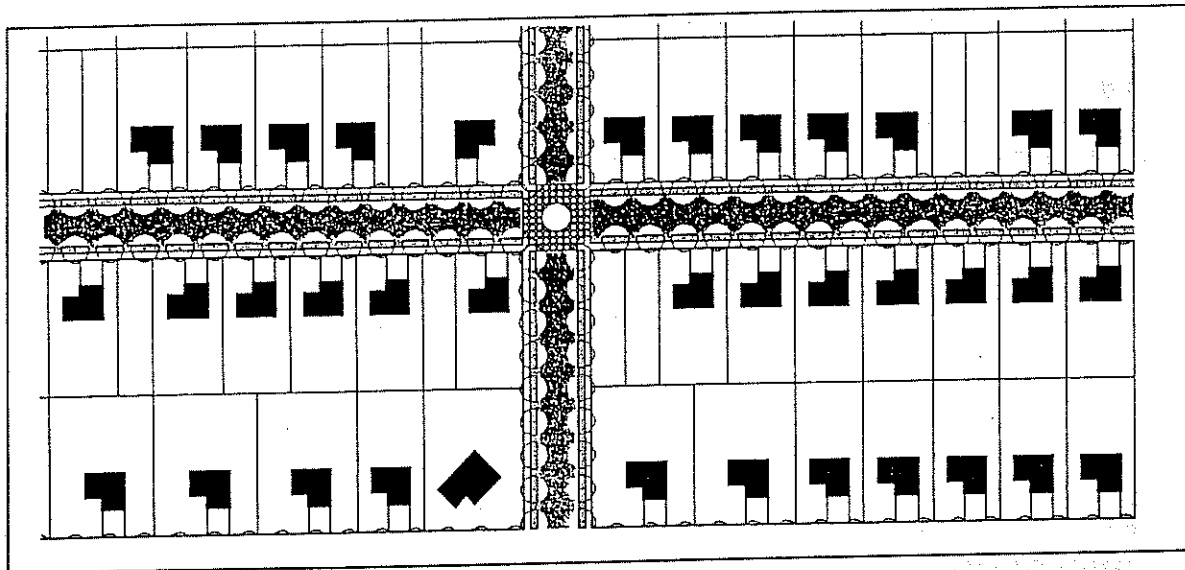
Typical Setbacks and Alignment in College Park

- Orientation and site coverage. The front of the new building in relationship to the front of other buildings along a block, and the percentage of the site that the building covers compared to nearby buildings.
- Maintaining materials within the district. Use materials common to the district and avoid the use of inappropriate materials in construction.
- Trim and detail. New construction should be compatible with historic buildings without necessarily copying their detail.
- Entrances and porch projections. Size, shape and proportion of entrances and porches.
- Roof forms. Shapes and materials.

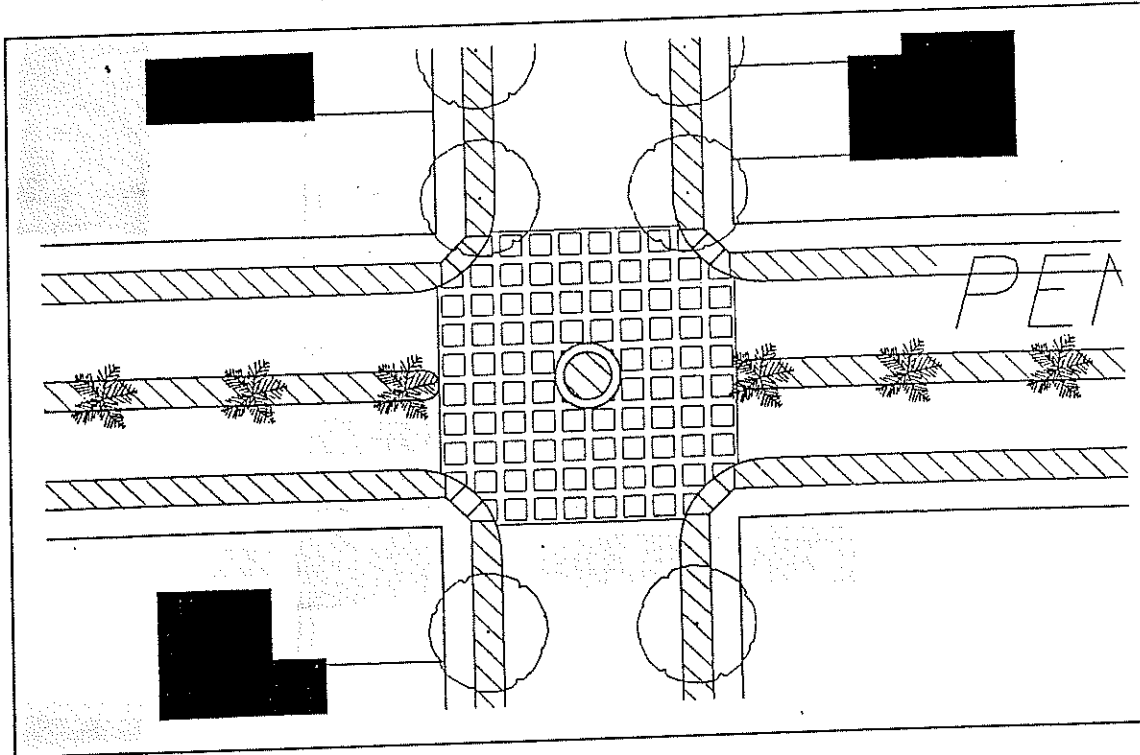
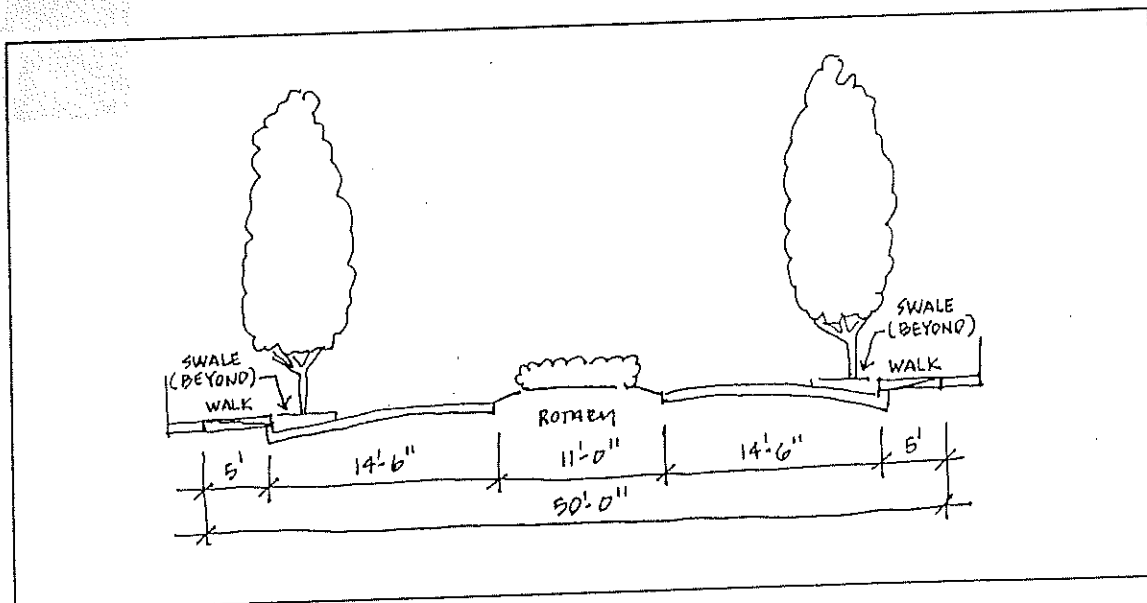
Rotary at Fordham

will reinforce the significance of Pennsylvania Avenue as the major north-south street, but will also help to control the speed of the automobile on this street. Two rotaries will provide a visual continuity. The use of rotaries in the center of this narrow neighborhood however should not be considered to address the concerns of through traffic. With the completion of the FDOT work and the rotaries traffic will be slowed on this particular heavily trafficked street.

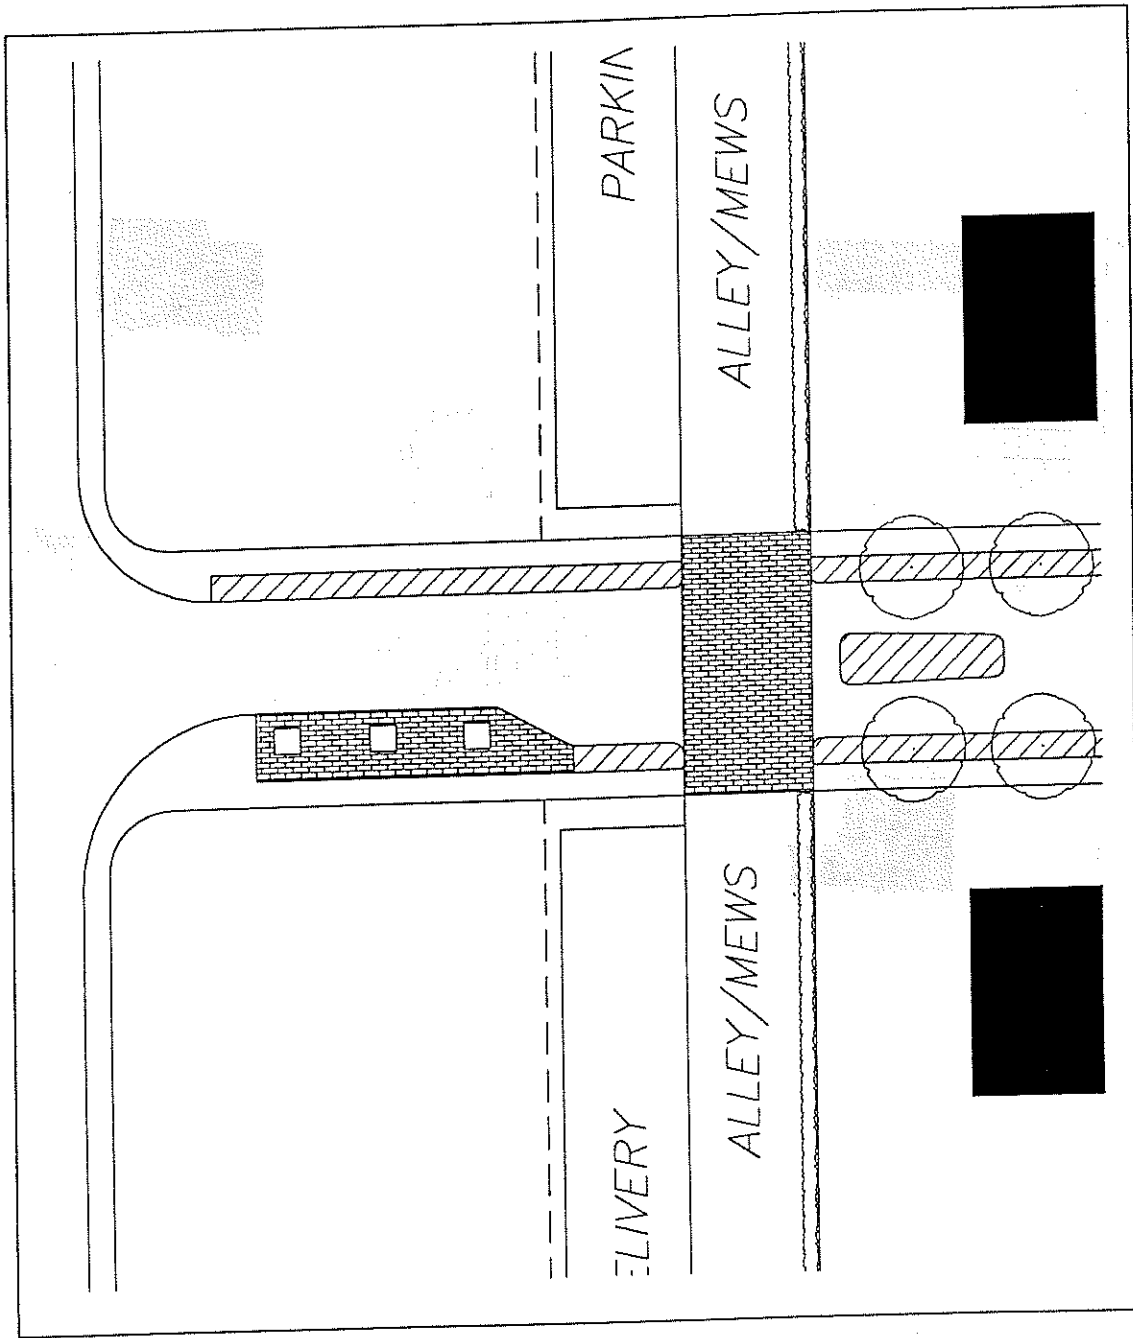
Alley/Mews Plan

- The alleys within the neighborhood are currently seen as messy, slightly threatening and a traffic nuisance. However the future development of a plan specifically for the alleys could be a great asset to this neighborhood. If the alleys could be considered as mews, such as the intimate mews throughout Great Britain which house small businesses, offices and services, the alleys with the existing commercial structures could be compatibly integrated into the neighborhood. Traffic on the alleys should be controlled to stay primarily within the alley- to -Dixie Highway domain. The shops and stores could have entries from Dixie or the Alley Mews, but an indication of a "neighborhood" should be established at the point where the alley intersects the street. The design of a cross walk of a varied color or texture could denote this difference, or the construction of an island at this intersection would help to distinguish the different domains. Commercial and retail business should be encouraged to remain within the domain of the alley- to- Dixie Highway. Parking behind the stores, and exits onto the alley and then back to Dixie Highway should be reinforced. The use of an island or a specific planting plan would reinforce the delineation of the areas.

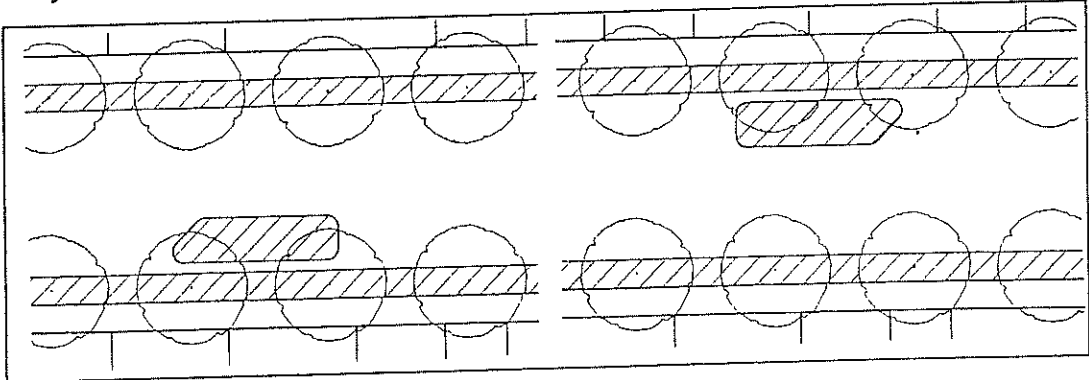
Typical bulb-out in right of way

Less drastic than a narrowing of all the streets, the District should, at a minimum, consider the use of "bulb outs" to narrow the street in selected areas as seen in the El Cid neighborhood.

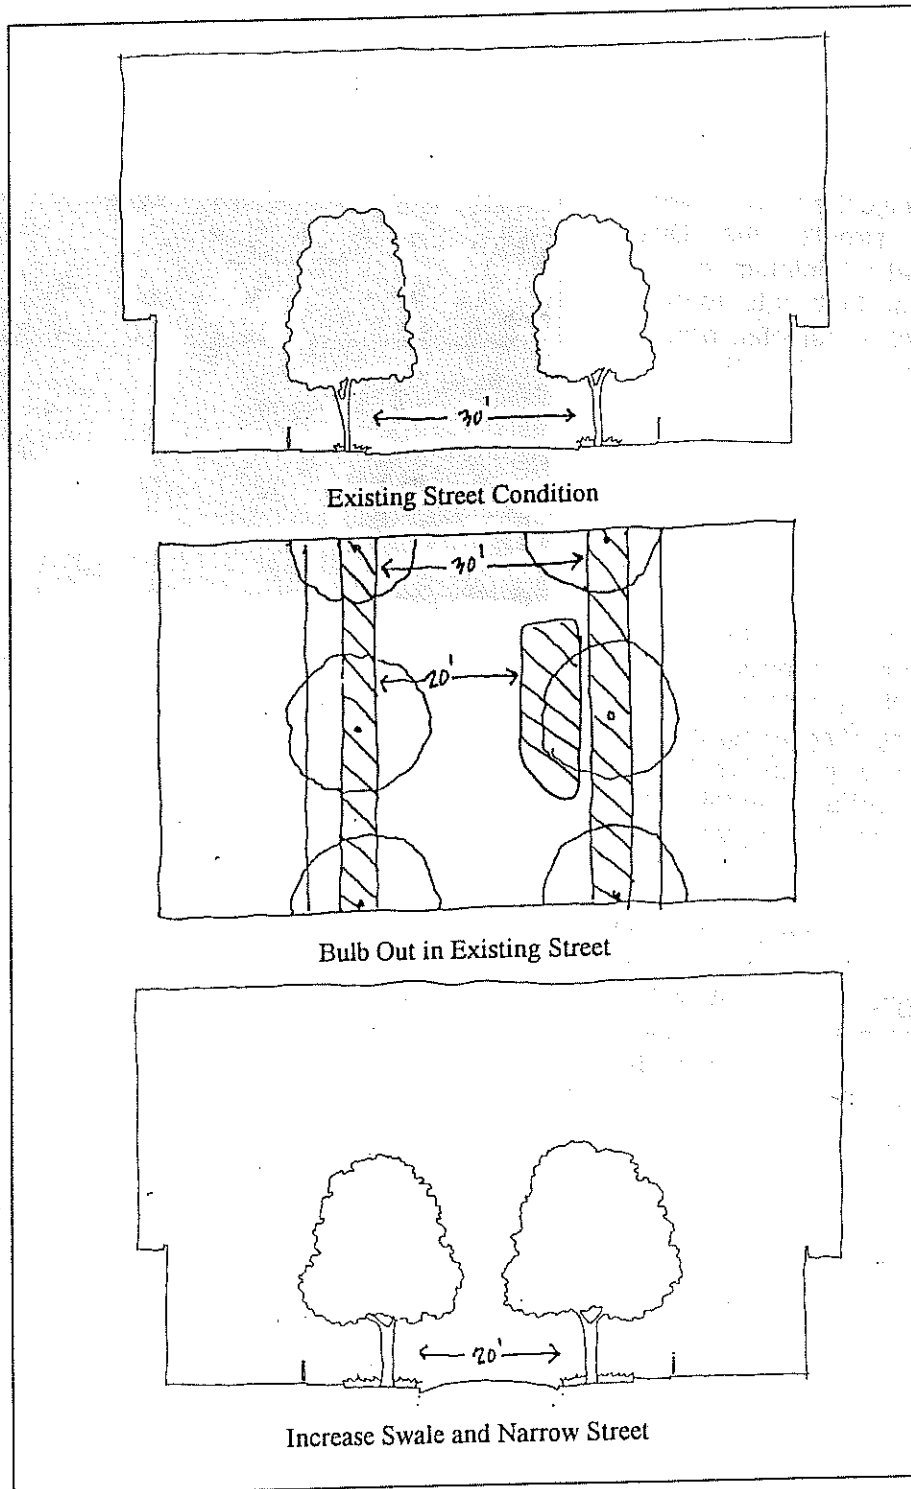
Diagram of street widths

Although the narrowing of streets may be considered a drastic change, this is perhaps the most important single thing that would affect the quality and character of this neighborhood. At a time when any street improvements are being planned, utilities rerouted or maintenance on the surfacing undertaken, this narrowing of the streets should be considered. This will allow for many of the other recommendations within this Master Plan to be better implemented and will address many of the concerns that have been expressed by the residents of College Park.

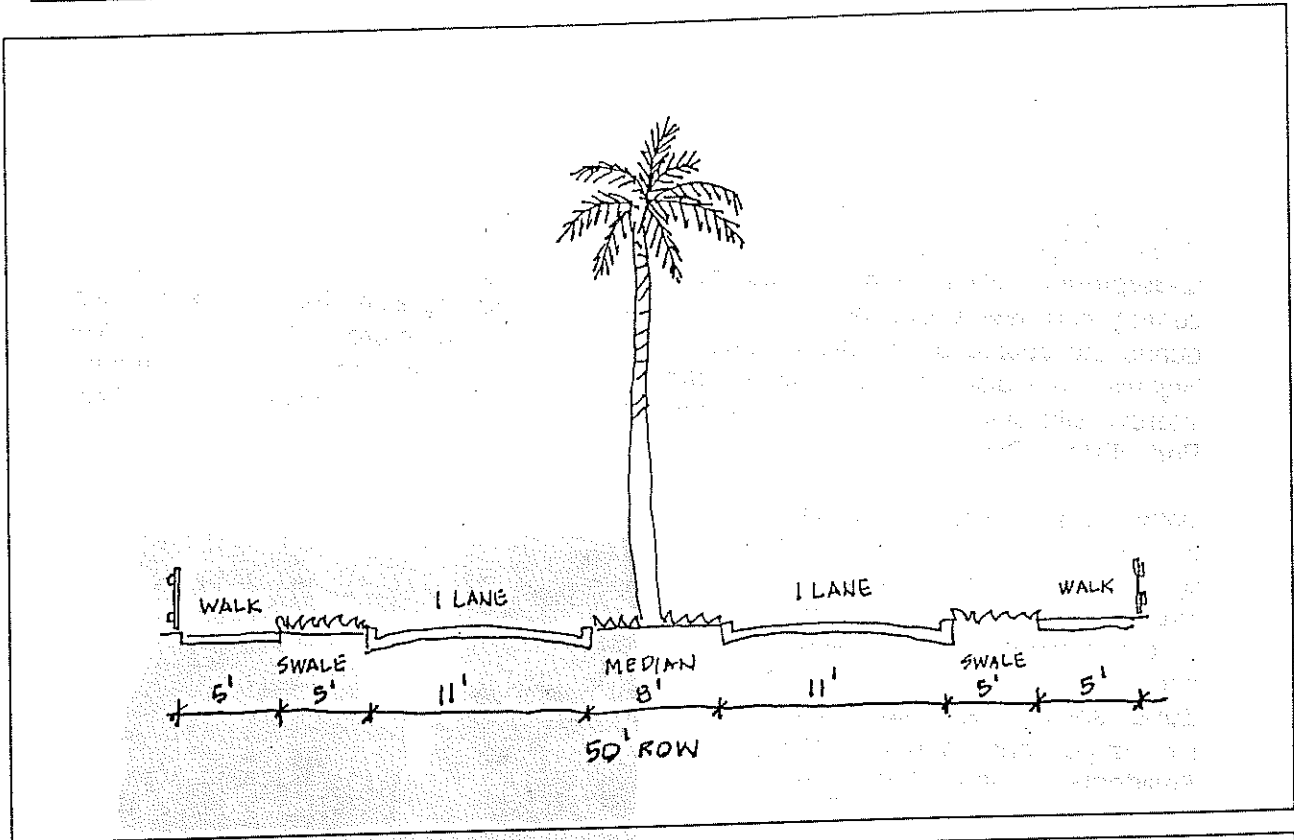
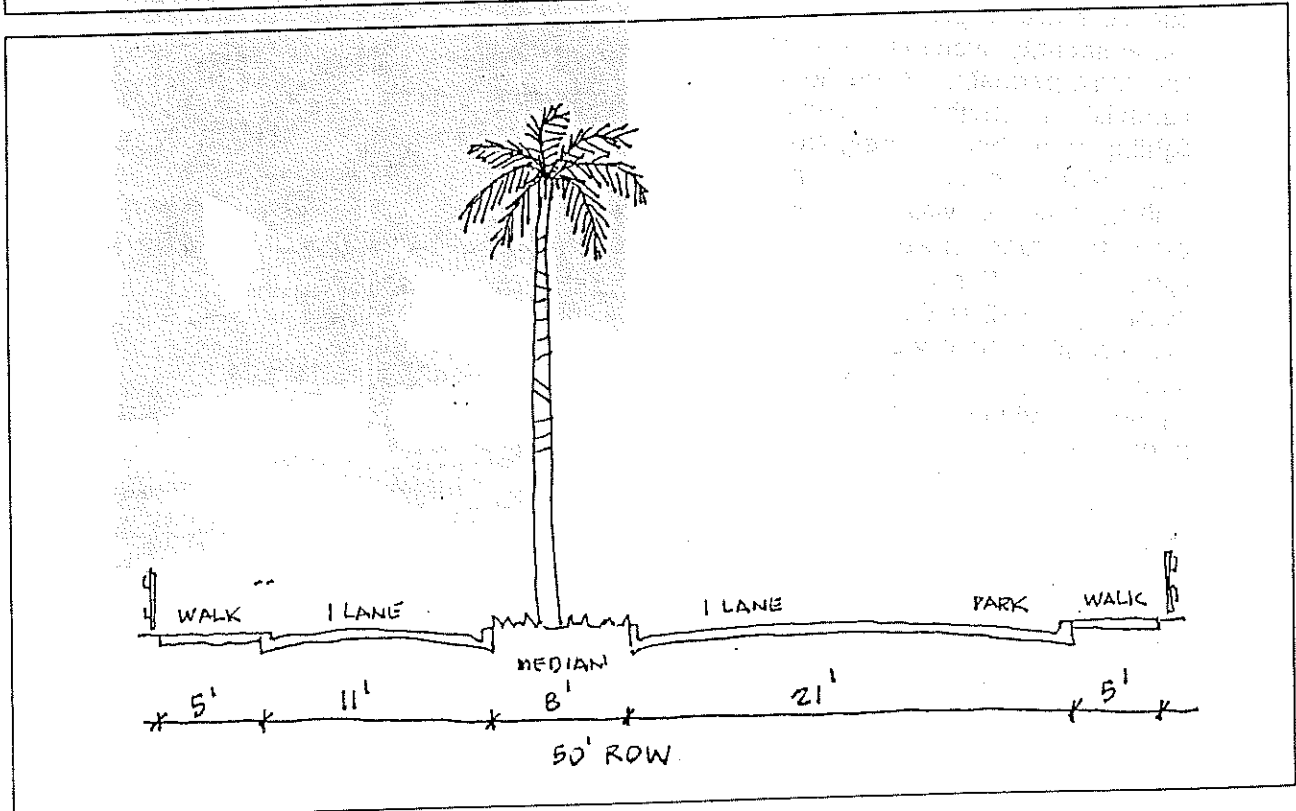
Median on Pennsylvania Avenue

A median constructed in Pennsylvania Avenue will provide a linear planting scheme that would lace its way through the length of the neighborhood. The median can be offset and allow for parallel planting along one side of Pennsylvania. We recommend the median be planted with palms because of its narrow section and to change the texture and provide contrast with the shade trees on the east-west streets. A minimal number of houses front Pennsylvania, thus locating a boulevard on this north-south axis does not conflict with the numerous drives along the east and west street.

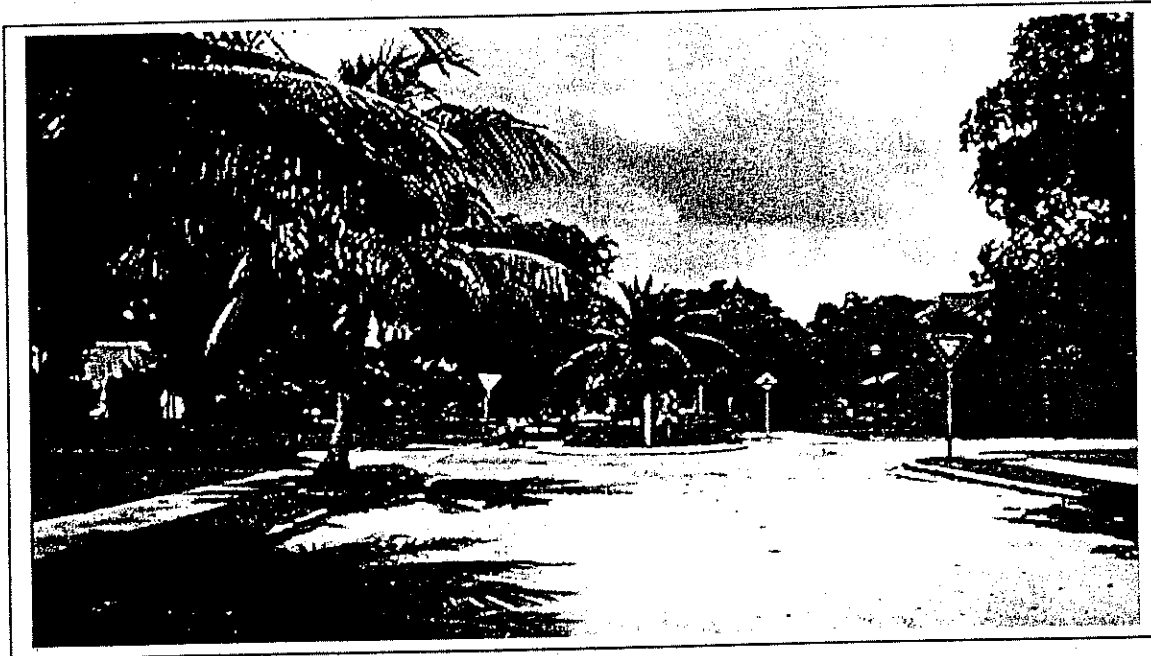
Traffic signs should be organized and located to be highly visible, without becoming neighborhood eyesores. Too often the islands and roundabouts intended to be landscaped beautifully, become the resting place for a conglomeration of speed signs, yield signs, pedestrian crossings and other traffic information. These signs should be located, instead, on the major highways with a singular speed sign at the entry point that establishes "speed limit within district 20 mph". With an effort to limit the use of traffic signs in the interior of the district, the neighborhood looks more pedestrian-oriented than car bound. Rather than signs that sprout up in unlikely places, a Signage Master Plan can determine the most effective location to deliver important information. For the residents within the district, knowledge of the speed is shared, even though the very wide streets are somewhat responsible for the encouragement of speeding across the district.

The boundaries of the College Park District are not immediately evident to the visitor. The clarification of its boundaries has both visual and practical benefits. An opportunity at North Federal Highway and North Dixie Highway at both the north and south ends could be established with the integration of an armature and simple identification sign on the new lamp posts, and then separate identification signposts can be designed for discreet entrances at the ends of the District's Drives.
